DEPARTMENT OF TRANSPORTATION

Quality Assurance and Source Inspection

Contract #: 04-0120F4Cty: SF/ALA Rte: 80 PM: 13.2/13.9File #: 69.28**WELDING INSPECTION REPORT****Resident Engineer:**Pursell, Gary**Address:** 333 Burma Road**City:** Oakland, CA 94607**Report No:** WIR-001116**Date Inspected:** 05-Dec-2007**Project Name:** SAS Superstructure**OSM Arrival Time:** 630**Prime Contractor:** American Bridge/Fluor Enterprises, a JV**OSM Departure Time:** 1730**Contractor:** Zhenhua Port Machinery Company, Ltd (ZPMC), Changxing Island **Location:** Shanghai, China**CWI Name:** Fu Yu Hong**CWI Present:** Yes No**Inspected CWI report:** Yes No N/A**Rod Oven in Use:** Yes No N/A**Electrode to specification:** Yes No N/A**Weld Procedures Followed:** Yes No N/A**Qualified Welders:** Yes No N/A**Verified Joint Fit-up:** Yes No N/A**Approved Drawings:** Yes No N/A**Approved WPS:** Yes No N/A**Delayed / Cancelled:** Yes No N/A**Bridge No:** 34-0006**Component:** OBG Second Weld Trial**Summary of Items Observed:**

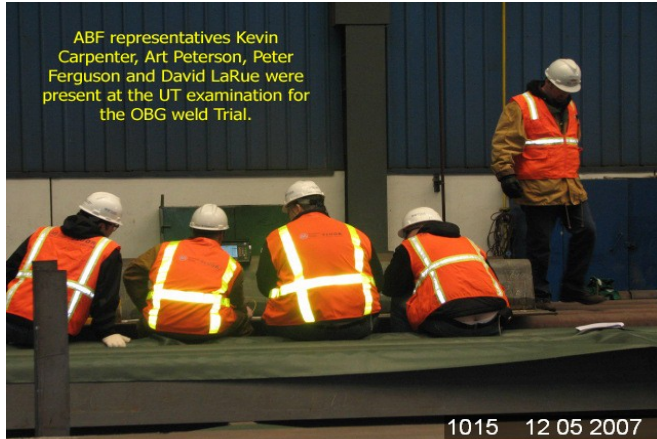
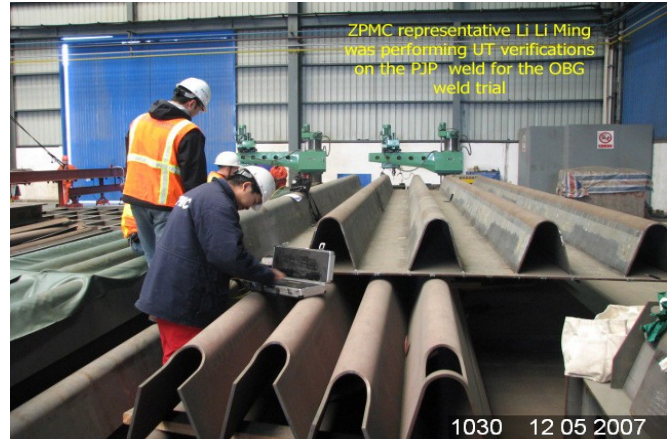
Item Description	WBS	Dwg No.	Status
<p>1 UT verifications on the PJP for the Second Weld Trial</p> <p>The QA Inspector performed 100% ultrasonic testing (UT) evaluation after Mr. Art Peterson on the partial penetration joint (PJP), at the 12 mm U-rib # U-75 weld joint # 5. The QA inspector concurred with Mr. Art Peterson findings (approximately 2 meters, 2 indications).</p> <p>The QA inspector performed 100% ultrasonic testing (UT) evaluation after Mr. Art Peterson on the partial penetration joint (PJP) at the 12 mm U-rib # U-73 weld joint # 1. The QA inspector concurred with Mr. David LaRue findings (approximately 2 meters).</p> <p>The QA inspector performed UT verifications to the weld # 2 from the U-rib U-05 after Mr. Li Li Ming. The QA inspector found a recordable 2.86 mm Lop with 40 % FSH, 70 mm from the left end of the rib that Mr. Li Li Ming missed. The QA inspector asked Mr. Art Peterson if ZPMC could reverify the indication. Mr. Li Li Ming found a 18% FSH no recordable indication. Mr. Art Peterson and Mr. David LaRue verified the indications as well. Mr. Art Peterson found evaluating with a USN-58 unit a maximum of 26% FSH and 2.5 mm of Lop; Mr. David LaRue found evaluating with the USN-58L 43% FSH and 2.96 mm Lop. Mr. Li Li Ming and the QA inspector rechecked the calibration and obtained similar values than before. Mr. David LaRue had a phone conversation with Mr. Warren Buehler who was coordinating the test from ABF and ZPMC. Mr. David LaRue brought it to the attention of Mr. Warren Buehler about the discrepancy obtained by the testers. Mr. David LaRue relayed that Mr. Warren Buehler directed to continue performing UT verifications. ZPMC re-examined the weld that ZPMC had already completed with no recordable indications (approximately 4 meters).</p>

<p>2 Connection plate assembly at the OBG Deck Mock-up</p> <p>The QA inspector performed random dimensional verifications of the bolted connection splice for the OBG Deck Mock-up. The QA inspector observed that ZPMC was hand bolting the splice # 4 and 5 at the connection plate. The QA inspector measured the alignment between the ribs at the bottom side of the ribs # U-01 and U-06, and U-02 and U-07. The QA inspector found a maximum of 2 mm of misalignment by weld # 1.</p>
